**SITE EVALUATION:**

**PETELER PORTABLE RAILWAY  
MANUFACTURING COMPANY/  
HARRIS MACHINERY  
501 THIRTIETH AVENUE SOUTHEAST  
MINNEAPOLIS, MINNESOTA**

**JESSICA BERGLIN  
PENNY PETERSEN  
CHARLENE ROISE  
HESS, ROISE AND COMPANY  
THE FOSTER HOUSE  
100 NORTH FIRST STREET  
MINNEAPOLIS, MINNESOTA 55401**

**APRIL 2013**

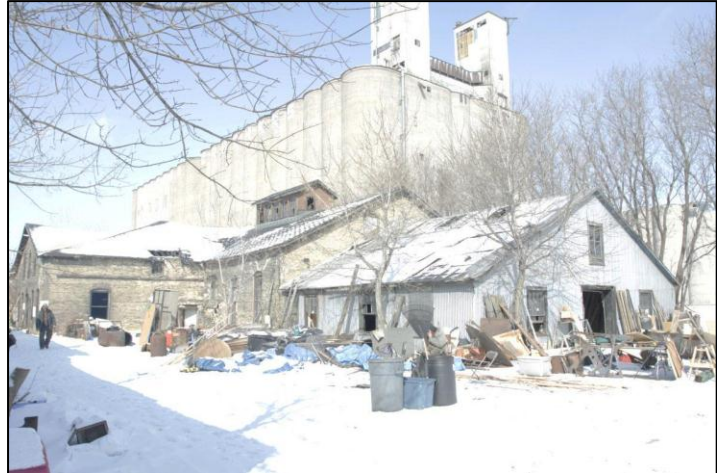
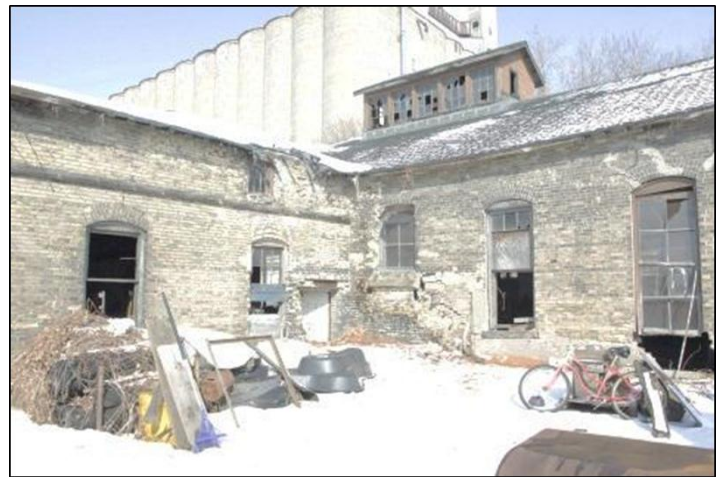
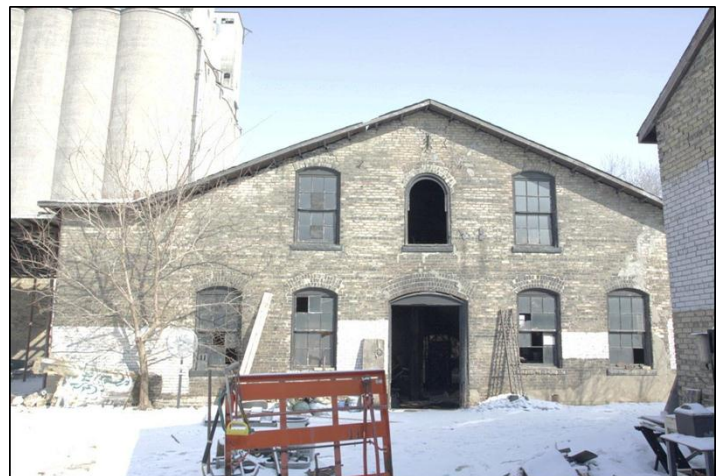
*These 2013 photographs illustrate the foundry's structural and material decay.*

Poor. The roof over the west half of the foundry has collapsed and the masonry shows signs of failure and structural movement. Many window sashes have been removed and several remaining windows have broken panes. In some openings, stone sills have been replaced with brick.

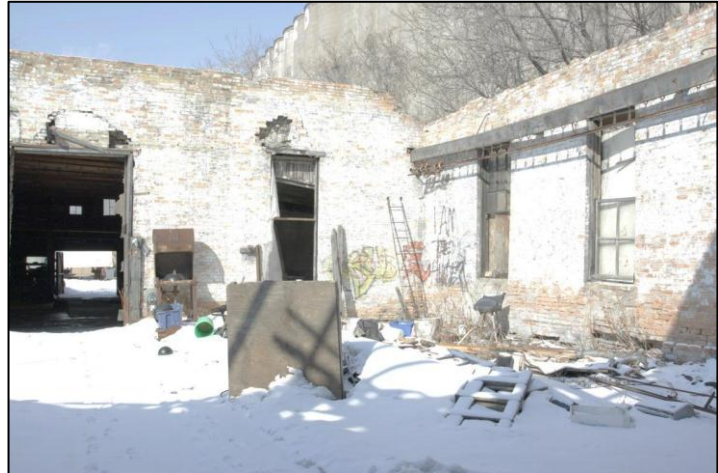
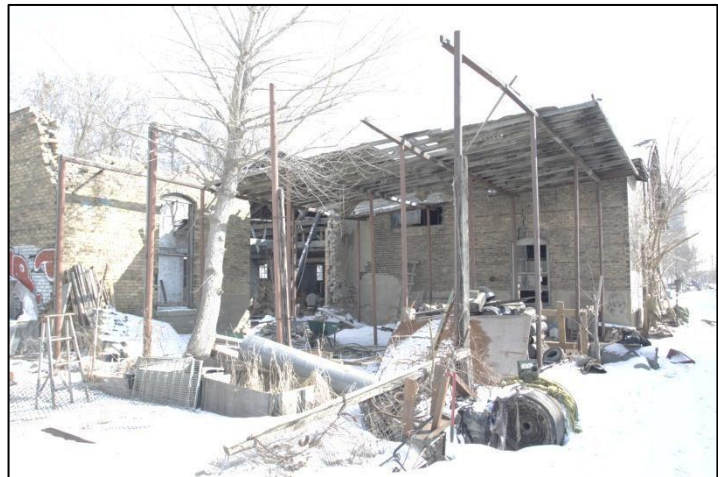
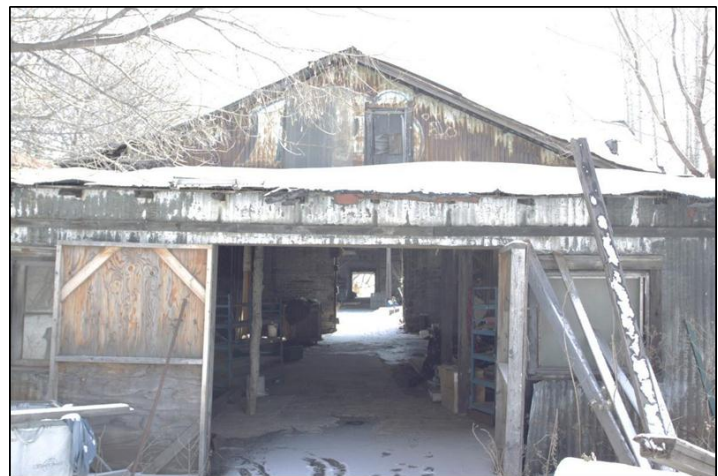
*The roof collapsed over the western half of the structure, causing further deterioration (top and middle). An addition on the west side of the foundry possibly dates to 1888 (bottom).*

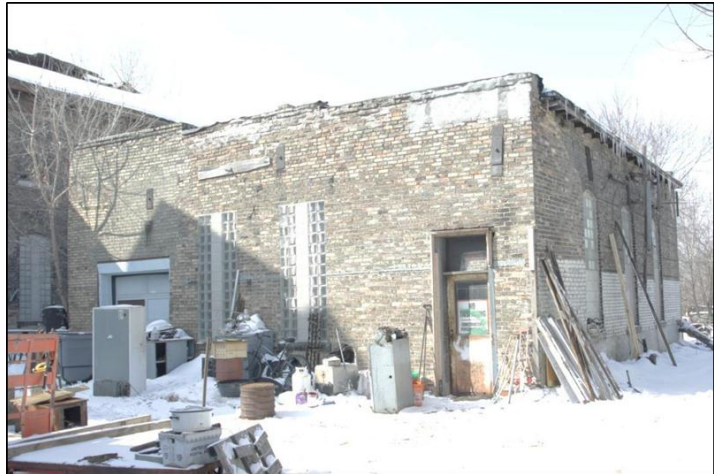
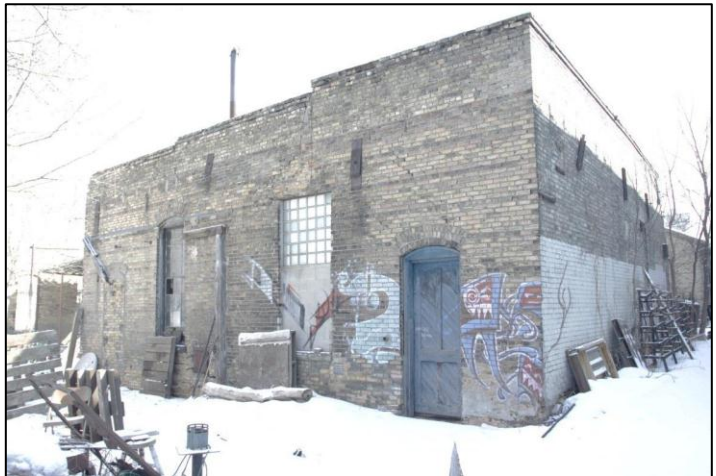
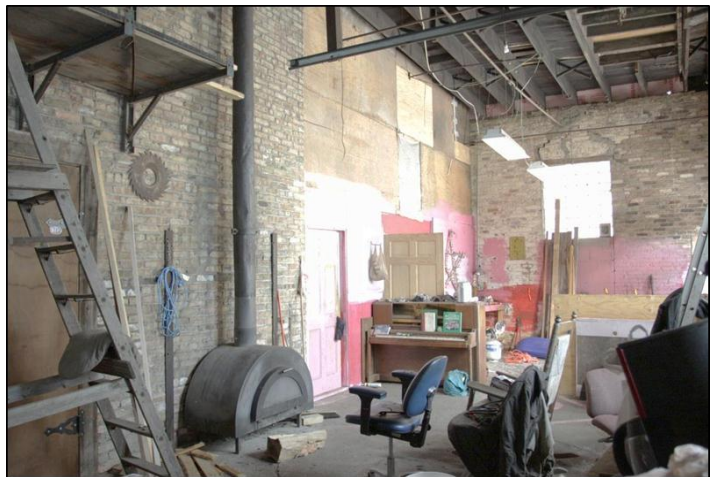
*The engine and boiler room has had several modifications, including the installation of a garage door, glass-block windows, and an interior frame partition.*

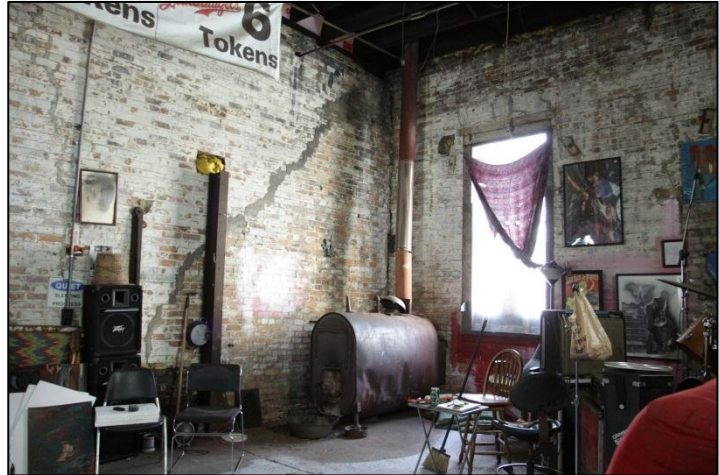
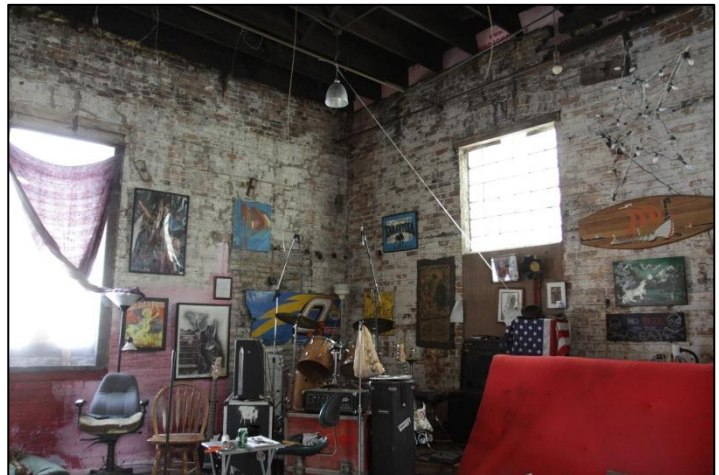
Poor. Nearly all of the historic windows have been removed. Several historic openings have been filled with glass block, concrete block, or brick; one historic door remains on the west wall. A garage door was installed on the east wall at an unknown date. A coal shed was demolished at an unknown date. There are several incidents of masonry failure and structural movement.

*Interior photographs show evidence of structural movement in the masonry (top). Window openings have been filled with glass block.*

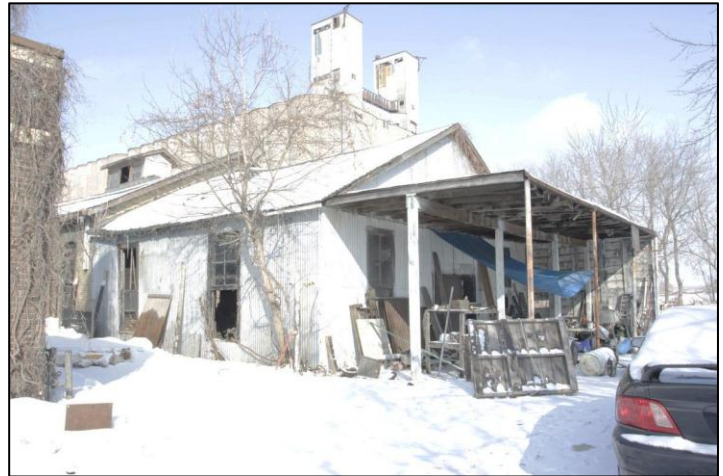
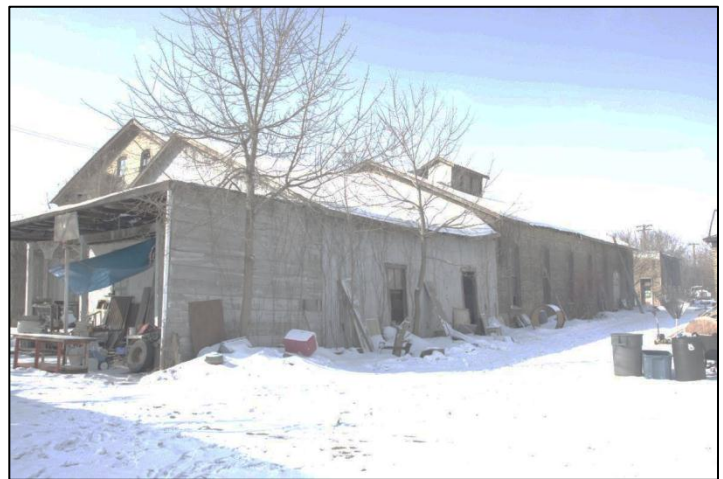
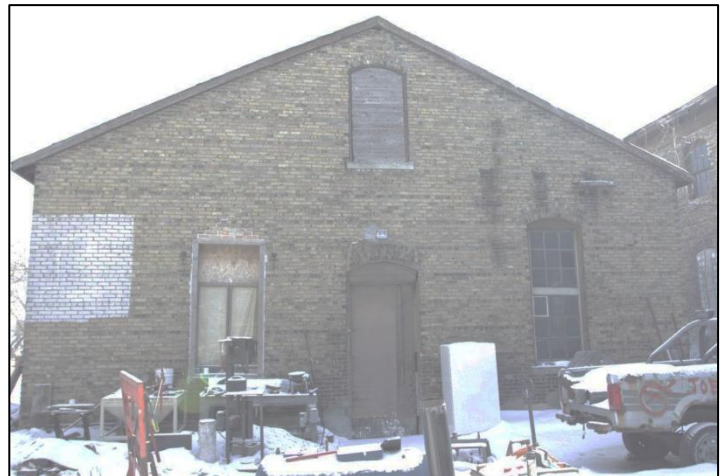
Fair. Unlike many of the other core buildings, the blacksmith shop retains several historic 9-over-9 windows. The masonry, however, shows signs of failure and there are several holes in interior walls. A shed addition with corrugated metal siding detracts from the original masonry structure.

*These 2013 photographs show the deteriorated condition of a shed addition on the east wall (top and middle), while the west wall (bottom) remains fairly intact.*

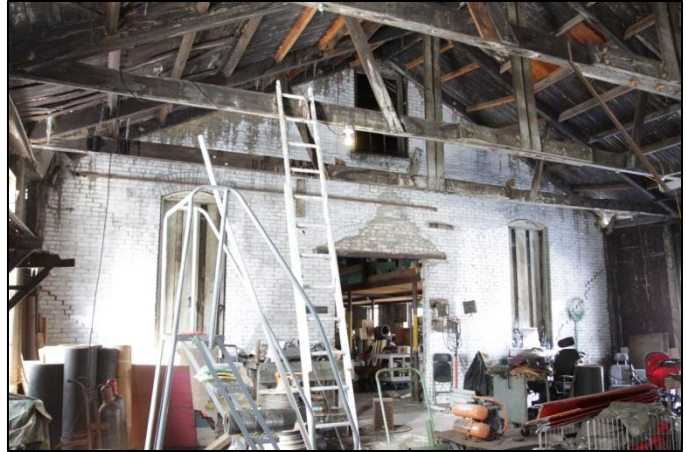
*Inside the east addition to the blacksmith shop. The shop's east wall was formerly an exterior wall, with windows and a doorway following the characteristic patterns of the other brick buildings.*

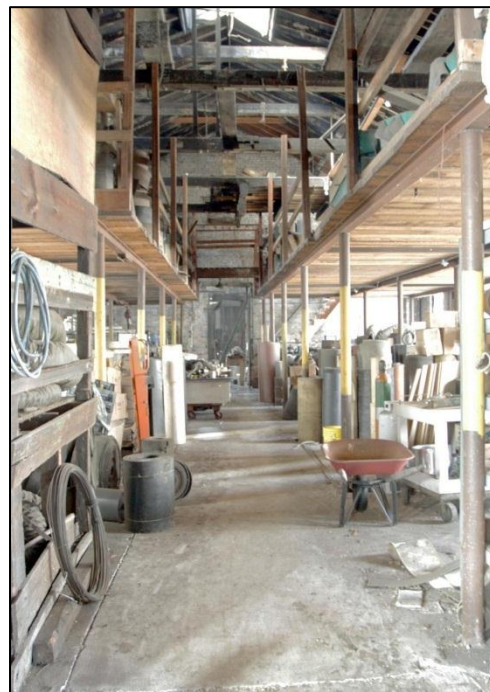
*The date of installation for the mezzanine is unknown. The wood components contrast with the original timber framing members, suggesting it was not original to the structure. The frame platform does not appear in Sanborn fire insurance maps, which is unusual for this type of construct.*

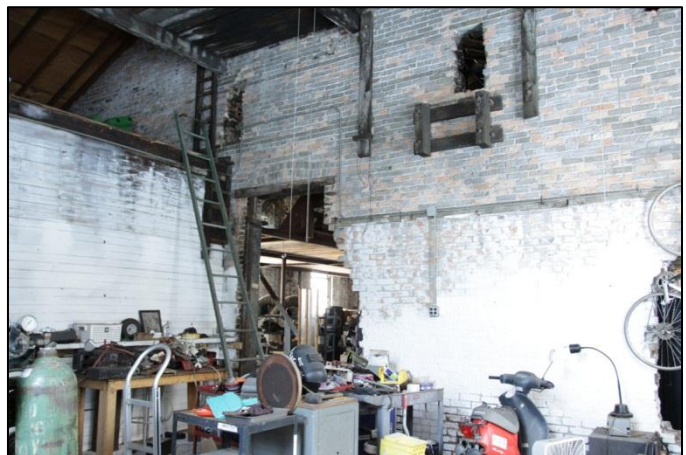
*Masonry deterioration is evident in this doorway to a room in the western portion of the blacksmith shop.*

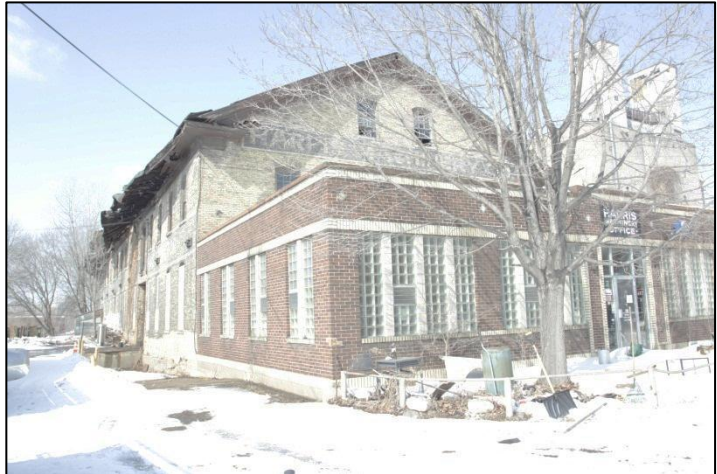
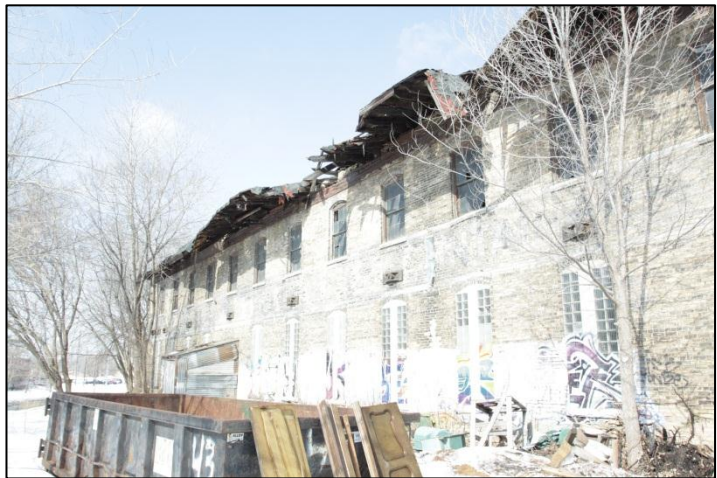
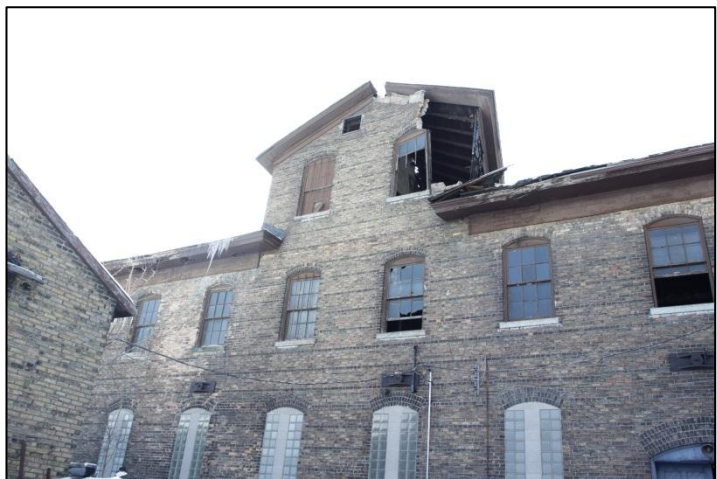
*The roof of the machine and erecting shop is in severe disrepair. Water infiltration continues to destabilize the structure.*

Poor. The heavy-timber structure remains fairly intact on the first and second floors. The roof, however, has recently collapsed and is in serious disrepair. Window openings on the first floor have been filled with concrete and glass blocks. Many of the historic second-floor windows remain, although some have broken or missing panes. An opening was cut in the south wall to install a non-historic garage door. Dropped ceilings have been installed in the eastern portion of the first floor.

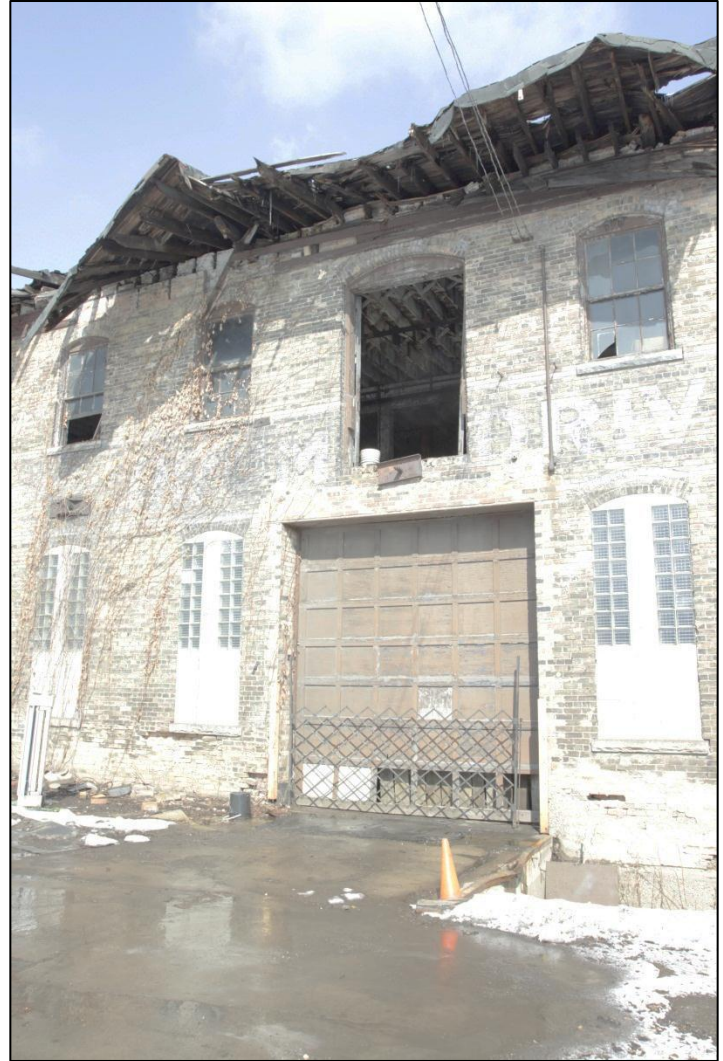
*An overhead garage door on the south wall is a non-historic alteration. Several original windows on the second floor have broken glass and all of the window openings on the first floor have been filled with concrete and glass blocks.*

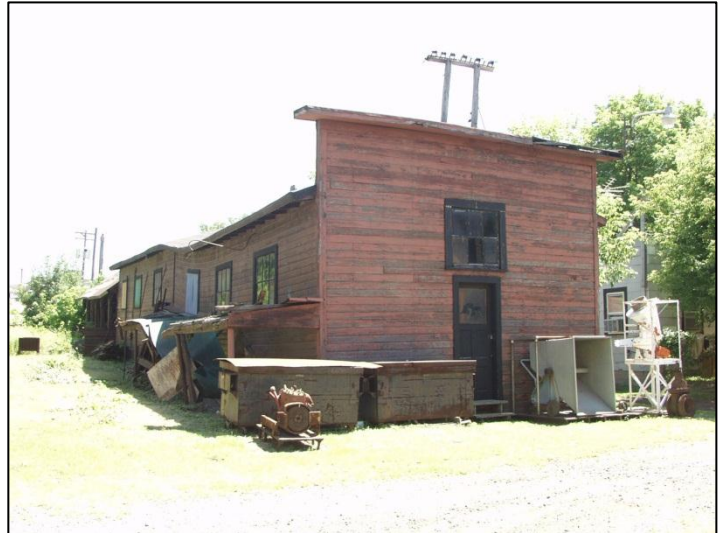
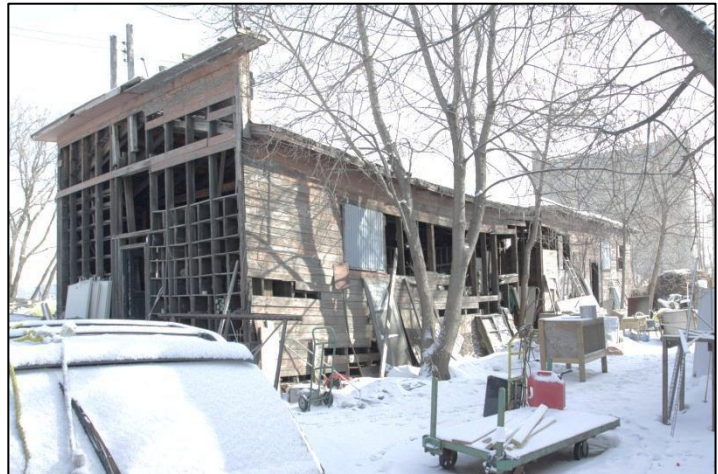
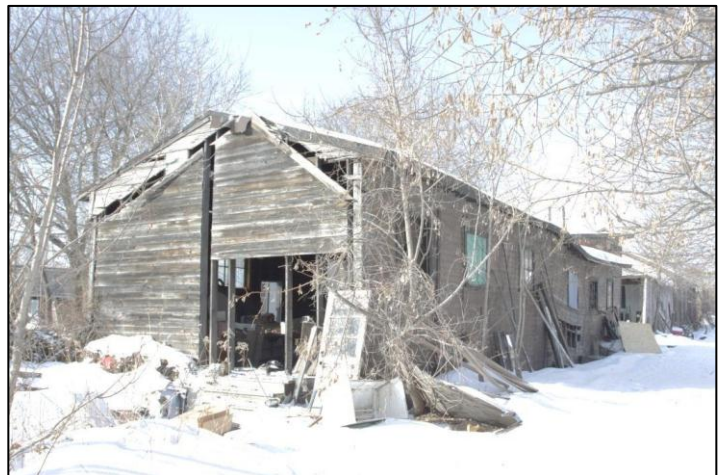
Poor. The building's foundation has settled unevenly, creating waves in the wood siding. The elimination of the building's front cladding and several windows has resulted in severe deterioration since the interior has become open to the elements.

*The shed's rapid decline is apparent when comparing a 2002 photograph (top) to current photographs (middle and bottom).*
