**SITE EVALUATION:**

**PETELER PORTABLE RAILWAY  
MANUFACTURING COMPANY/  
HARRIS MACHINERY  
501 THIRTIETH AVENUE SOUTHEAST  
MINNEAPOLIS, MINNESOTA**

**JESSICA BERGLIN  
PENNY PETERSEN  
CHARLENE ROISE  
HESS, ROISE AND COMPANY  
THE FOSTER HOUSE  
100 NORTH FIRST STREET  
MINNEAPOLIS, MINNESOTA 55401**

**APRIL 2013**

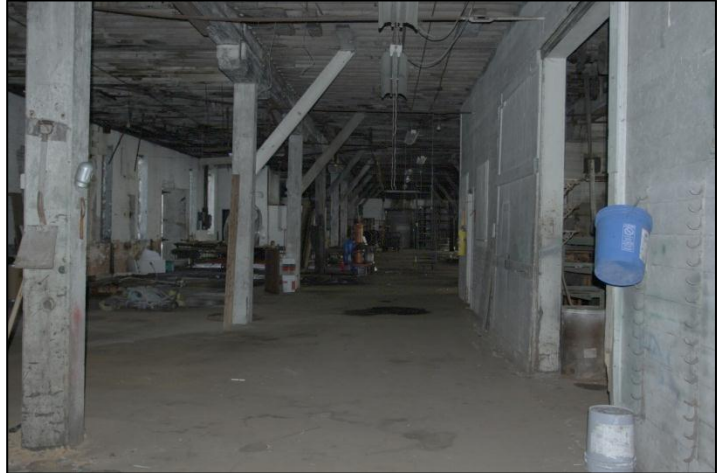
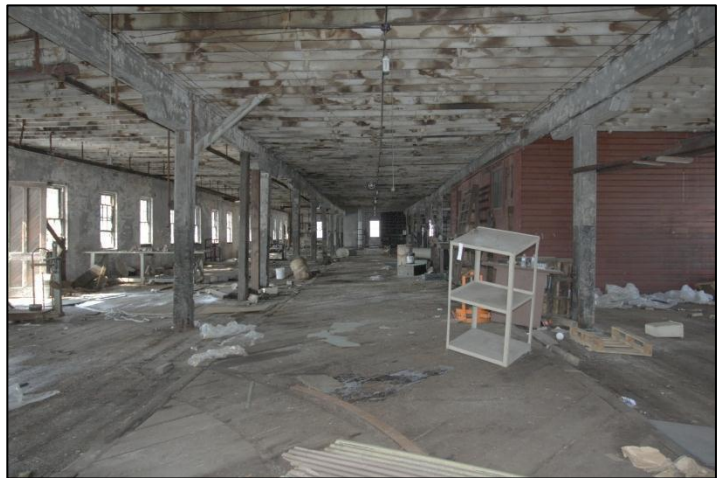
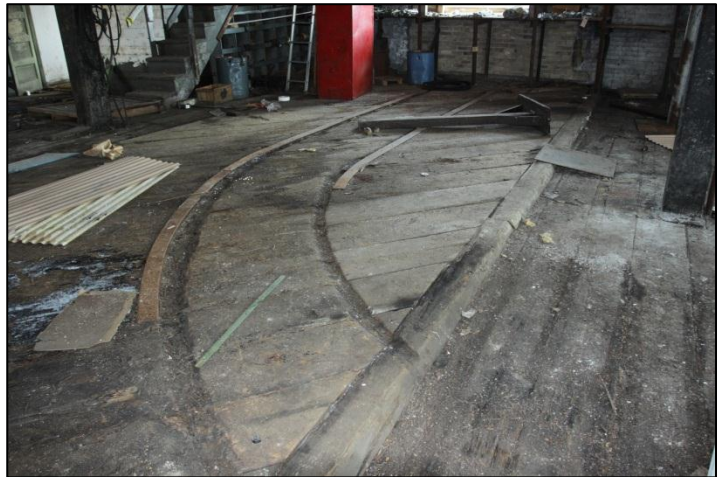
*The interior retains its heavy-timber structure on both the first (top) and second (middle) floors. The central bay on the second floor holds a raised platform with a track at the eastern end (bottom).*

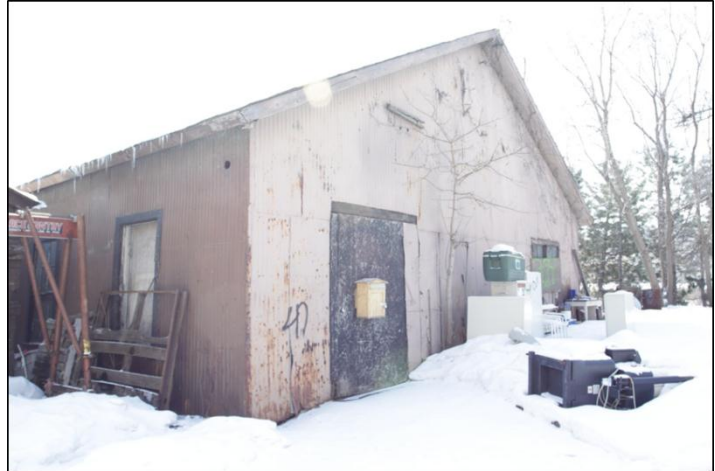
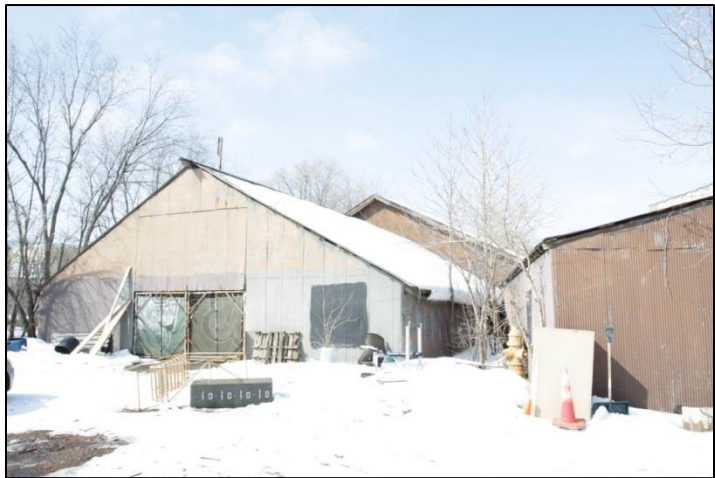
*The original shop (top) is surrounded by non-historic additions on the east and north (bottom) and has been clad in corrugated-metal panels that are not original.*

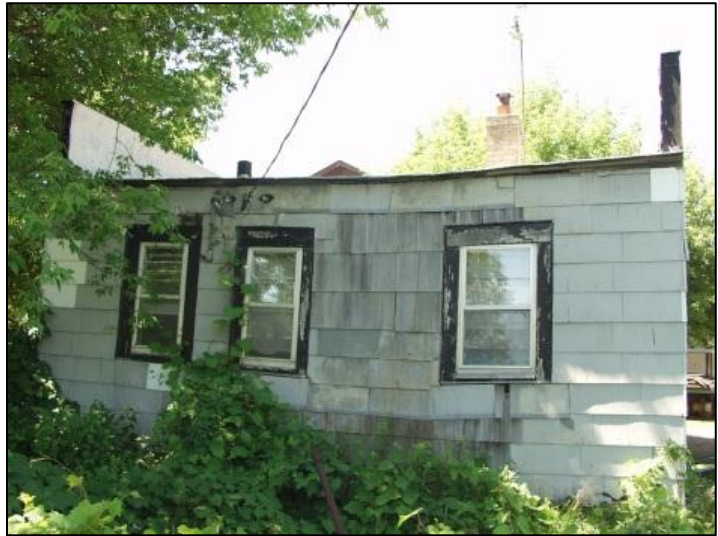
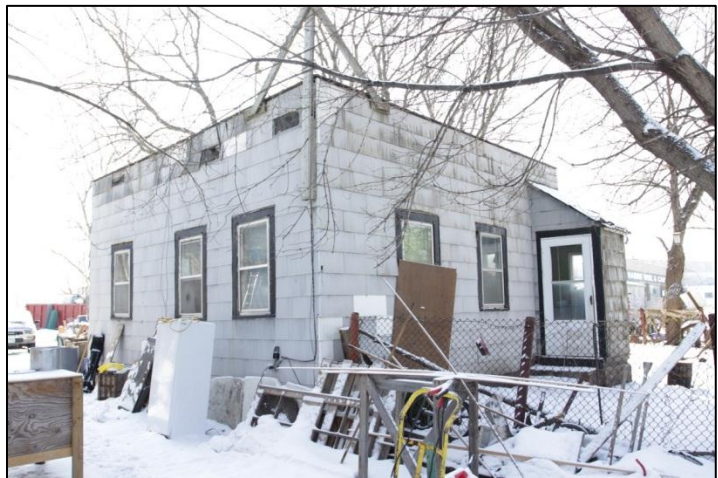
*These 2002 (top) and 2013 (bottom) site photographs illustrate that little has changed over the recent decade. The tall parapet is an identifying feature from the 1899 office.*

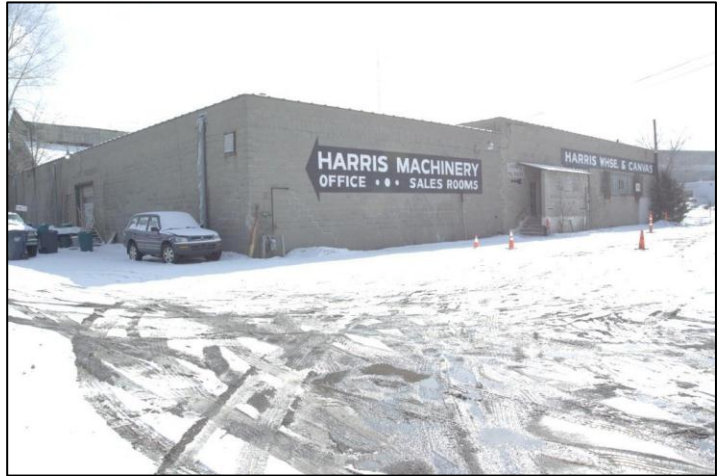
*Little has changed on the exterior of this concrete-block building. A compatible addition (foreground) was constructed on the north side of the original building (background), which was used as a canvas retail shop.*
